**DEPARTMENT OF TRANSPORTATION**

Contract #: 04-0120F4Cty: SF/ALA Rte: 80 PM: 13.2/13.9File #: 69.28**WELDING INSPECTION REPORT****Resident Engineer:** Pursell, Gary**Address:** 333 Burma Road**City:** Oakland, CA 94607**Report No:** WIR-012348**Date Inspected:** 02-Mar-2010**Project Name:** SAS Superstructure**OSM Arrival Time:** 645**Prime Contractor:** American Bridge/Fluor Enterprises, a JV**OSM Departure Time:** 1845**Contractor:** Zhenhua Port Machinery Company, Ltd (ZPMC), Changxing Island **Location:** Shanghai, China

**Segment-10AE**

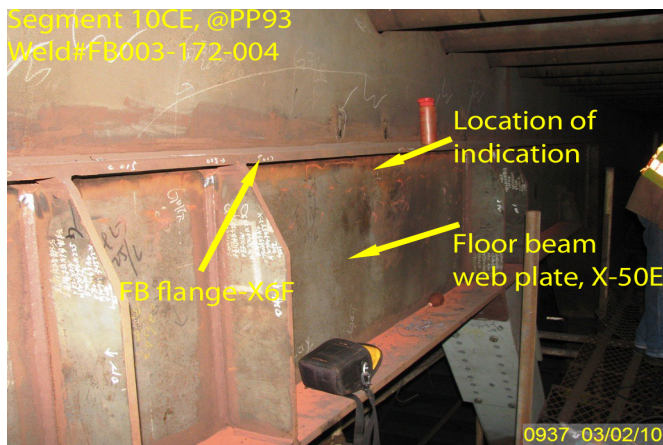
During random Quality Assurance Visual review of welds located on segment 9DW, this Quality Assurance Inspector (QA) discovered the following issues:

-One (1) linear indication measuring approximately 28 mm in length.

1. FB003-172-004, Longitudinal crack, approximately 28 mm in length @ PP88, Y location-11600 mm from Bike Path side.

-These welds are Fillet weld joining the Floor beam Web to Flange.

- The indications were discovered visually and confirmed by Magnetic particle Testing (MT) by Caltrans QA.

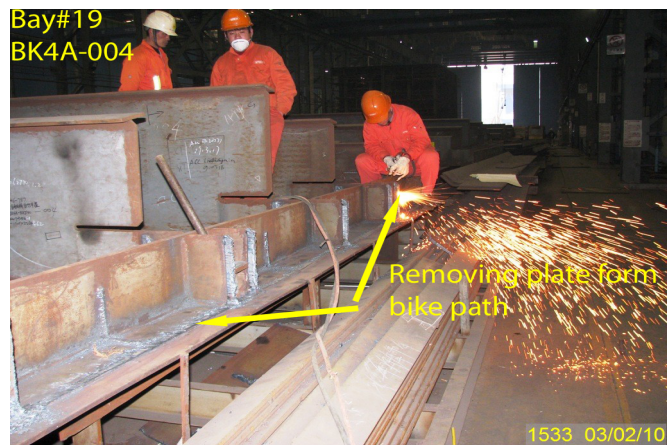
During random in process inspection of bike path, this QA inspector observed that ZPMC personal cutting parts of

BK4A-004 by oxy flame cutting process. Because of problem in design of bike path, ZPMC personal welded a bike path segment incorrect. For further information, please see the attached pictures below.

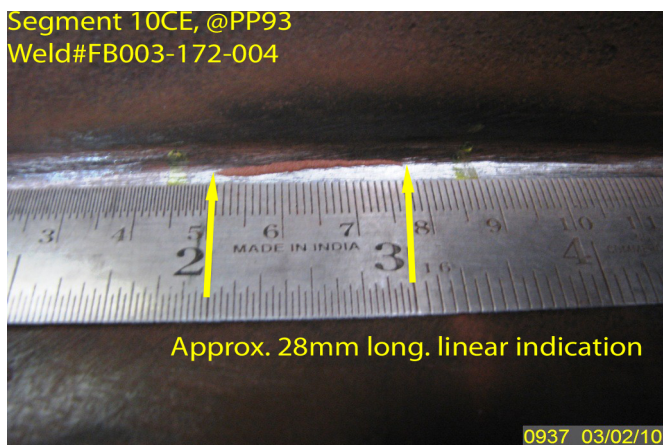
This QA inspector performed VT of approximately 100% of the area previously tested and accepted by ZPMC Quality Control personnel. The member is identified as OBG Components. The weld designations reviewed are as follows. For further information, please see attached pictures.
